SECTION 4. REPAIR OF METAL PROPELLERS

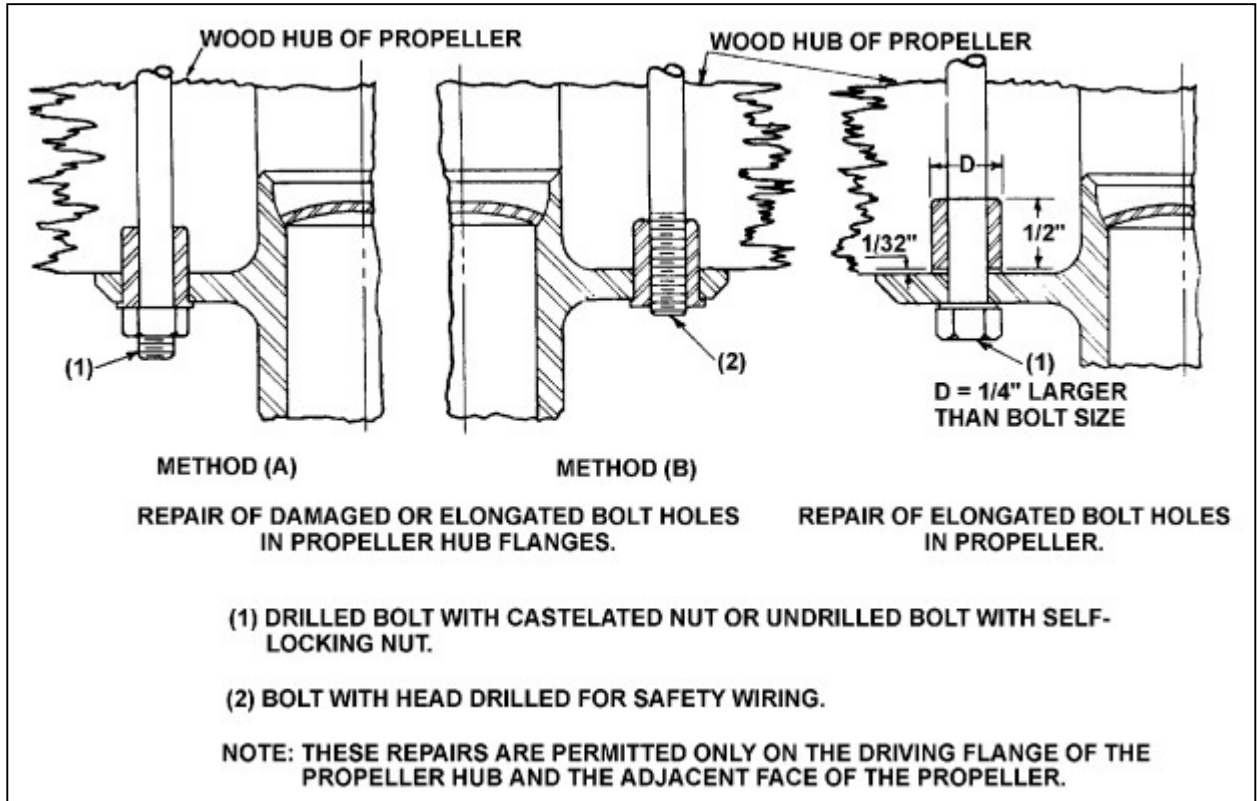
FIGURE 8-29. Repair of fixed-pitch hub and propeller with elongated or damaged bolt holes.

When the fixed-pitch propeller bolt holes in a hub or crankshaft become damaged or oversized, it is permissible to make repairs by using methods (A) or (B) in figure 8-29, or by use of aircraft standard bolts 1/16-inch larger than the original bolts. Make the repairs in accordance with the recommendations of the propeller metal hub manufacturer or the engine manufacturer, as applicable. Obtain from the engine or propeller hub manufacturer suitable flange bushings with threaded or smooth bores, as illustrated in methods (A) or (B) of figure 8-29. Drill the flange and insert the bushings as recommended by the propeller to accommodate the bushings, and protect the holes with 2 coats of aluminum paint or other high moisture-resistant coating. Use bolts of the same size as those originally used. Any of the following combinations may be used: (1) drilled head bolt and castellated nut, (2) drilled head bolt and threaded bushing, or (3) undrilled bolt and self-locking nut. Where it is desirable to use oversized bolts, obtain suitable aircraft-standard bolts 1/16-inch larger than the original bolts. Enlarge the crankshaft propeller flange holes and the propeller hub holes sufficiently to accommodate the new bolts without more than 0.005-inch clearance. Such reboring will be permitted only once. Further repairs of bolt holes may be in accordance with the methods listed in (A) or (B) of figure 8-29.

NOTE: Method (A) or (B) is preferred over the oversized bolt method, because a propeller hub flange re-drilled in accordance with this latter

method will always require the re-drilling of all new propellers subsequently used with the re-drilled flange.
